## **SAFETY INSPECTION ON LEVEL CROSSING JPL 727 KM 537 +453 PATAK-PATHUKAN ROAD, SLEMAN, YOGYAKARTA**

**Dian Setiawan M**  
Department of Civil Engineering  
Universitas Muhammadiyah  
Yogyakarta  
Jl. Lingkar Selatan, Kasihan,  
Bantul, Yogyakarta, Indonesia  
[diansetiawanm@ft.umy.ac.id](mailto:diansetiawanm@ft.umy.ac.id)

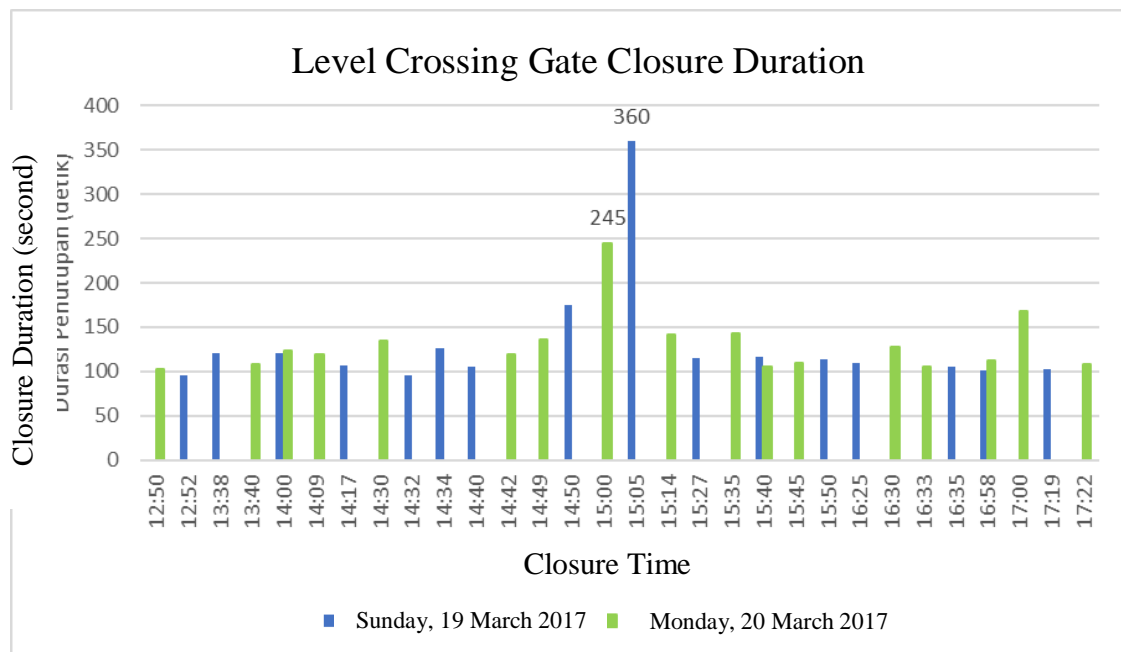
Figure 2 Level Crossing Gate Closure Duration

A survey of level crossing gate closure duration is done to find variations of level crossing gate closure duration caused by the passing train. The data of level crossing gate closure duration for two days of observation are shown in Figure 2 below.

2. Some parameters are analysed as the impact of level crossing gate closing, including as follows:
  - a. The longest closure duration of level crossing gate occurred on Sunday, March 19, 2017 at 15:05 for 360 seconds, while on Monday, March 20, 2017 occurred at 15:00 for 245 seconds.

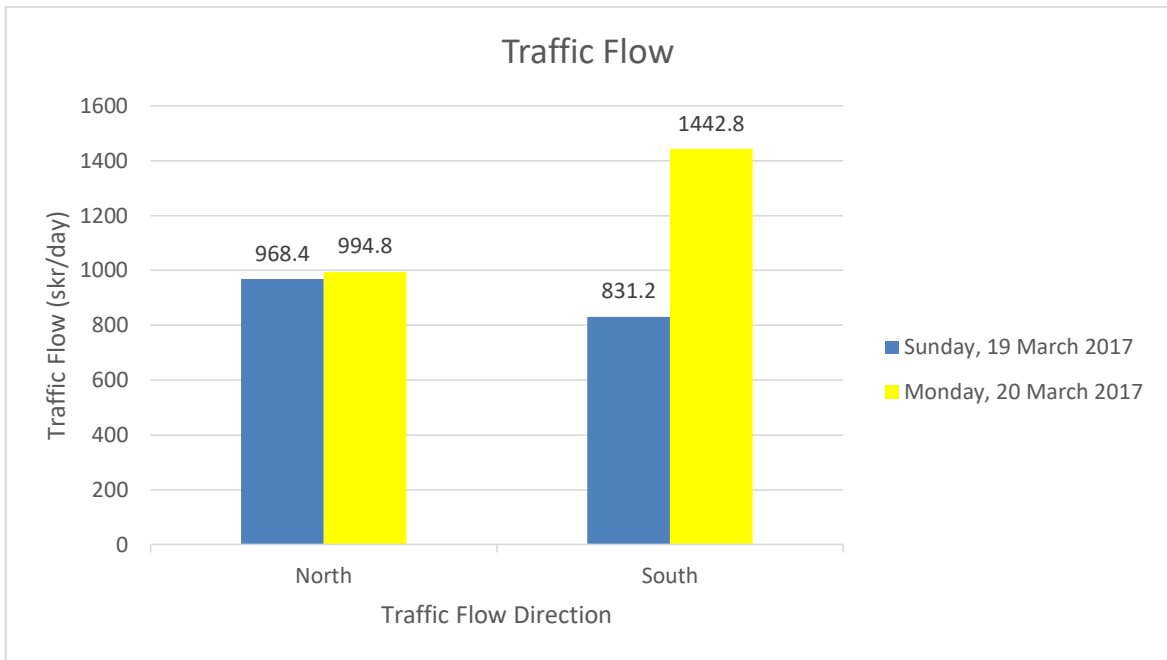
Figure 3 Traffic Flow

The data of traffic flow survey result at level crossing is shown in Figure 3.

- b. The highest traffic flow that occurred on Sunday, March 19, 2017 comes from the North side that is equal to 1932 vehicles/day or equal to 969 skr/day. Furthermore, the highest traffic flow that occurred on Monday, March 20, 2017 comes from the South side that is equal to 2956 vehicles/day or equal to 1443 skr/day.

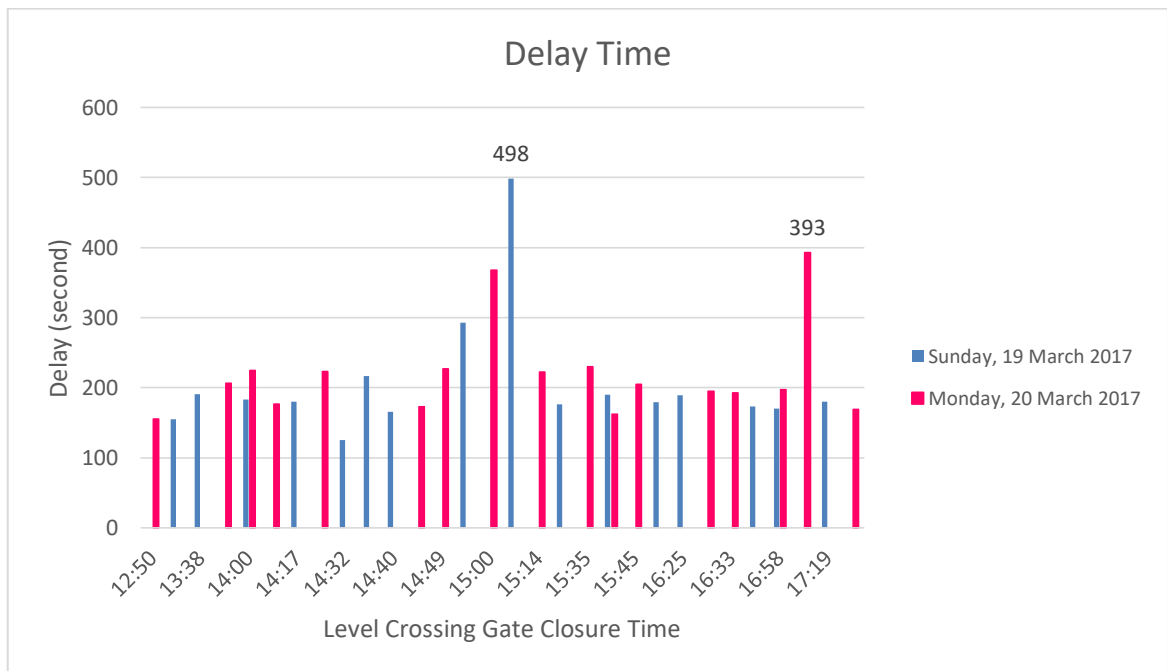
Figure 4 Delay Time

The queue length varies on each approach lane of level crossing for each level crossing gate closure time. The data of delay time can be seen in Figure 4.

From the survey of delay time and vehicles queue length that conducted for 6 hours from 12:00 to 18:00 on Sunday, 19 March 2017, it can be obtained the result that the longest delay time occurred at 15:05 for 498 seconds. The delay time is influenced by the duration of the level crossing gate closure due to the passage of two trains at almost the same time, causing the vehicle queue length is 65 meters in the North side and 87 meters in the South side of level crossing. Furthermore, from the survey of delay time and vehicles queue length that conducted for 6 hours from 12:00 to 18:00 on Monday, 20 March 2017, it can

be obtained the results that the longest delay time occurred at 17:00 for 393 seconds which is causing the vehicle queue length at that hour is 31 meters in the North side and 125 meters in the South side of level crossing.

- c. The longest delay time on Sunday, March 19, 2016 occurred at 15:05 for 498 seconds with a queue length is 65 meters from the North side and 78 meters from the South side. Moreover, the longest delay time on Monday, March 20, 2017 occurred at 17:00 for 393 seconds with a queue length of 31 meters from the North Side and 125 meters from the South Side.

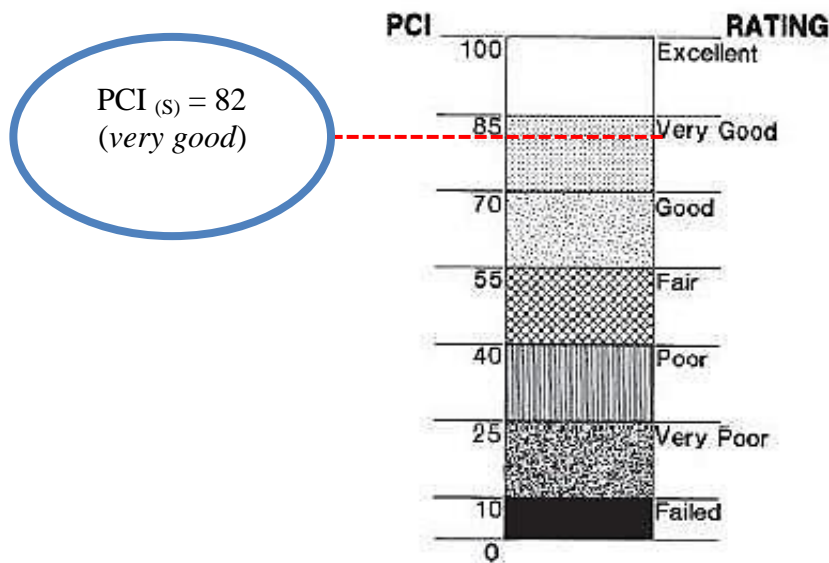
Figure 5 PCI Value Chart

Based on calculations, Total Deduct Value (TDV) is 35 with Q value is 3, resulting Corrected Deduct Value (CDV) is 18 from the CDV chart. Furthermore, the pavement condition value is obtained by subtracting 100 (one hundred) with the value of CDV that has been obtained. If the CDV value is known, then the PCI value of each segment unit can be calculated by the formula (5).

From the PCI value of each segment unit, it can be concluded that the amount of PCI value of this road segment as in the following figure.

3. There are 4 types of damage on the road segment JPL 727 KM 537 + 453 along the 200 meters North-South direction, which are : patching (9.33%), bleeding (0.22%), depression (0.8%), and railroad crossing (4.8%). The value of the pavement conditions

index (PCI) is 82% therefore it can be concluded that the road pavement is in very good condition.
