## Rapid Visual Screening (RVS) for School Buildings after Earthquake in Lombok, West Nusa Tenggara, Indonesia

A Pujianto<sup>1</sup>, H Prayuda<sup>1</sup>, S A P Rosyidi<sup>1</sup>, F Monika<sup>1</sup> and R Faizah<sup>1</sup>

<sup>1</sup>Department of Civil Engineering, Faculty of Engineering, Universitas Muhammadiyah Yogyakarta, Bantul, Daerah Istimewa Yogyakarta, Indonesia

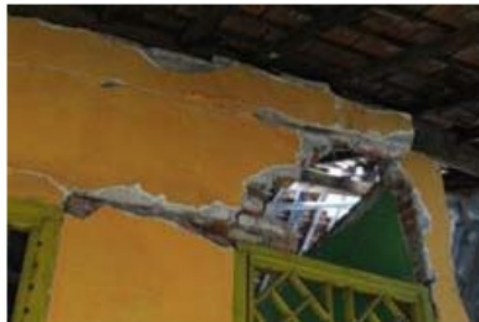
**Figure 10.** Damage to wall components that do not have good connections with doors and windows

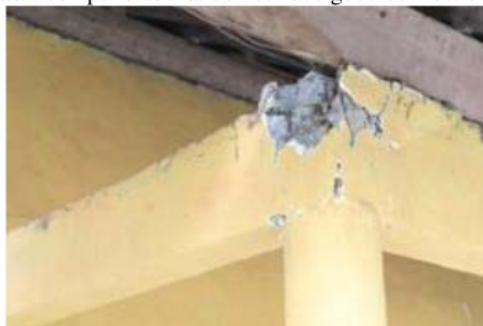
**Figure 11.** Damage to beam joints and columns

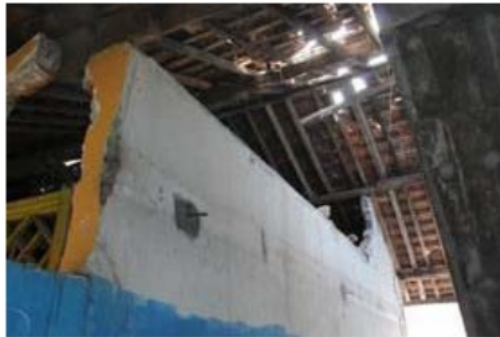
damage is found on the roof components. Based on the results of direct observation in the field, the roof structure in general still uses wood construction that is quite old.

Apart from age, this damage is also affected by improper construction methods for roof structure work; it can be seen that there is no good connection between tile and easel made of steel structure so that in the event of a shock, tile is very easy to lose and fall. General damage that occurs in the horizontal component in the form of a ceiling drop due to not having a strong bond. While structural conditions only experience mild to moderate cracks, which are not expected to disturb structural conditions if quickly repaired.

**Figure 12.** Damage to the roof frame structure

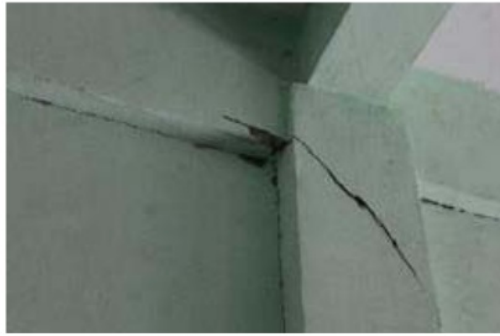
**Figure 13.** Damage to column components

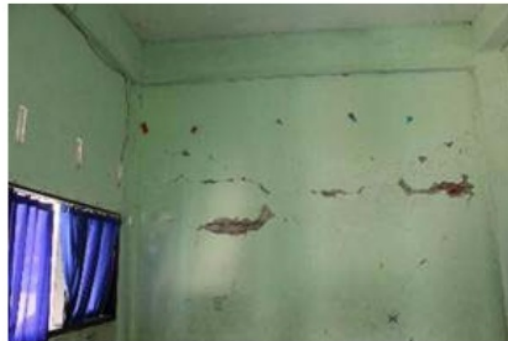
**Figure 14.** Horizontal cracks occur on the wall
