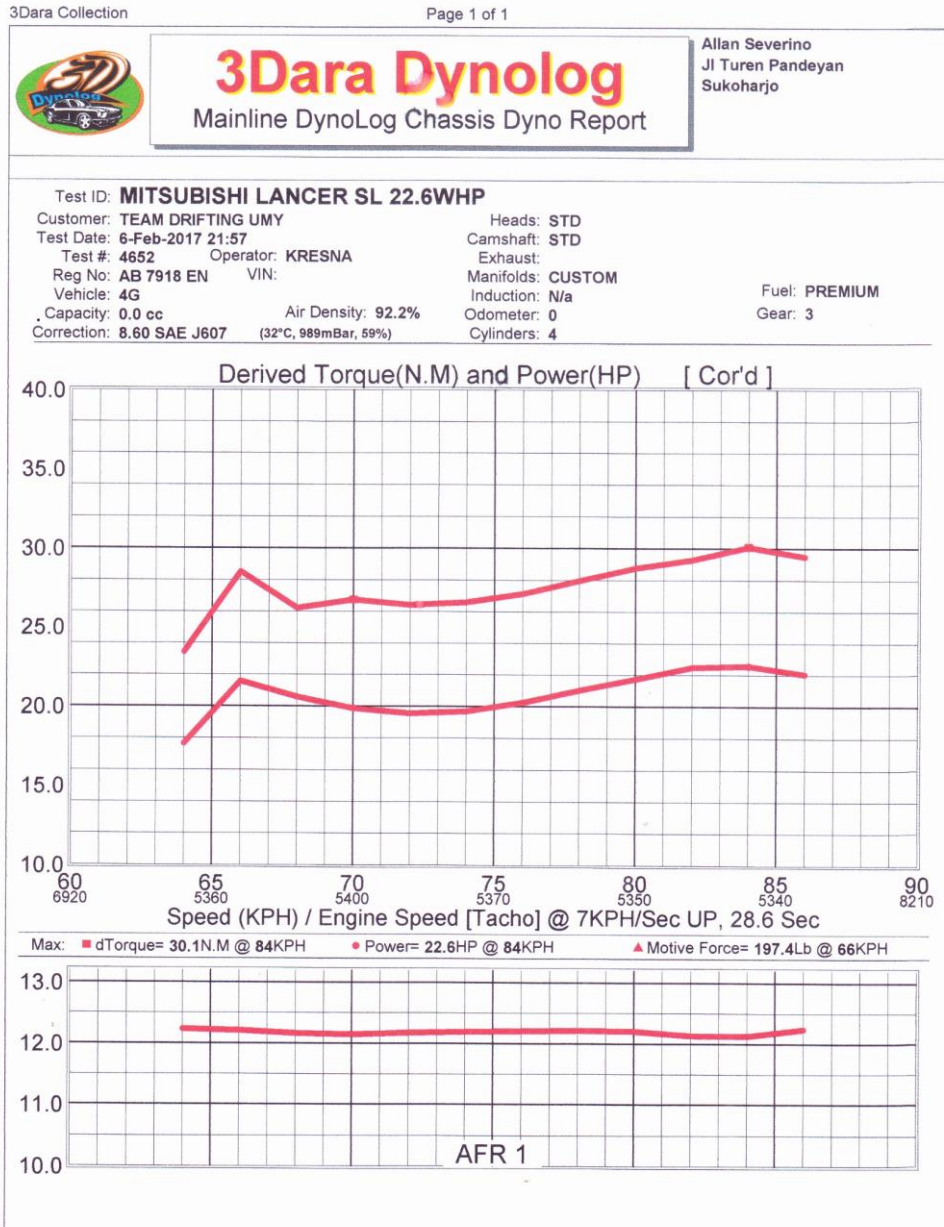
Lampiran 1

Data awal Dynotest sebelum dilakukan development

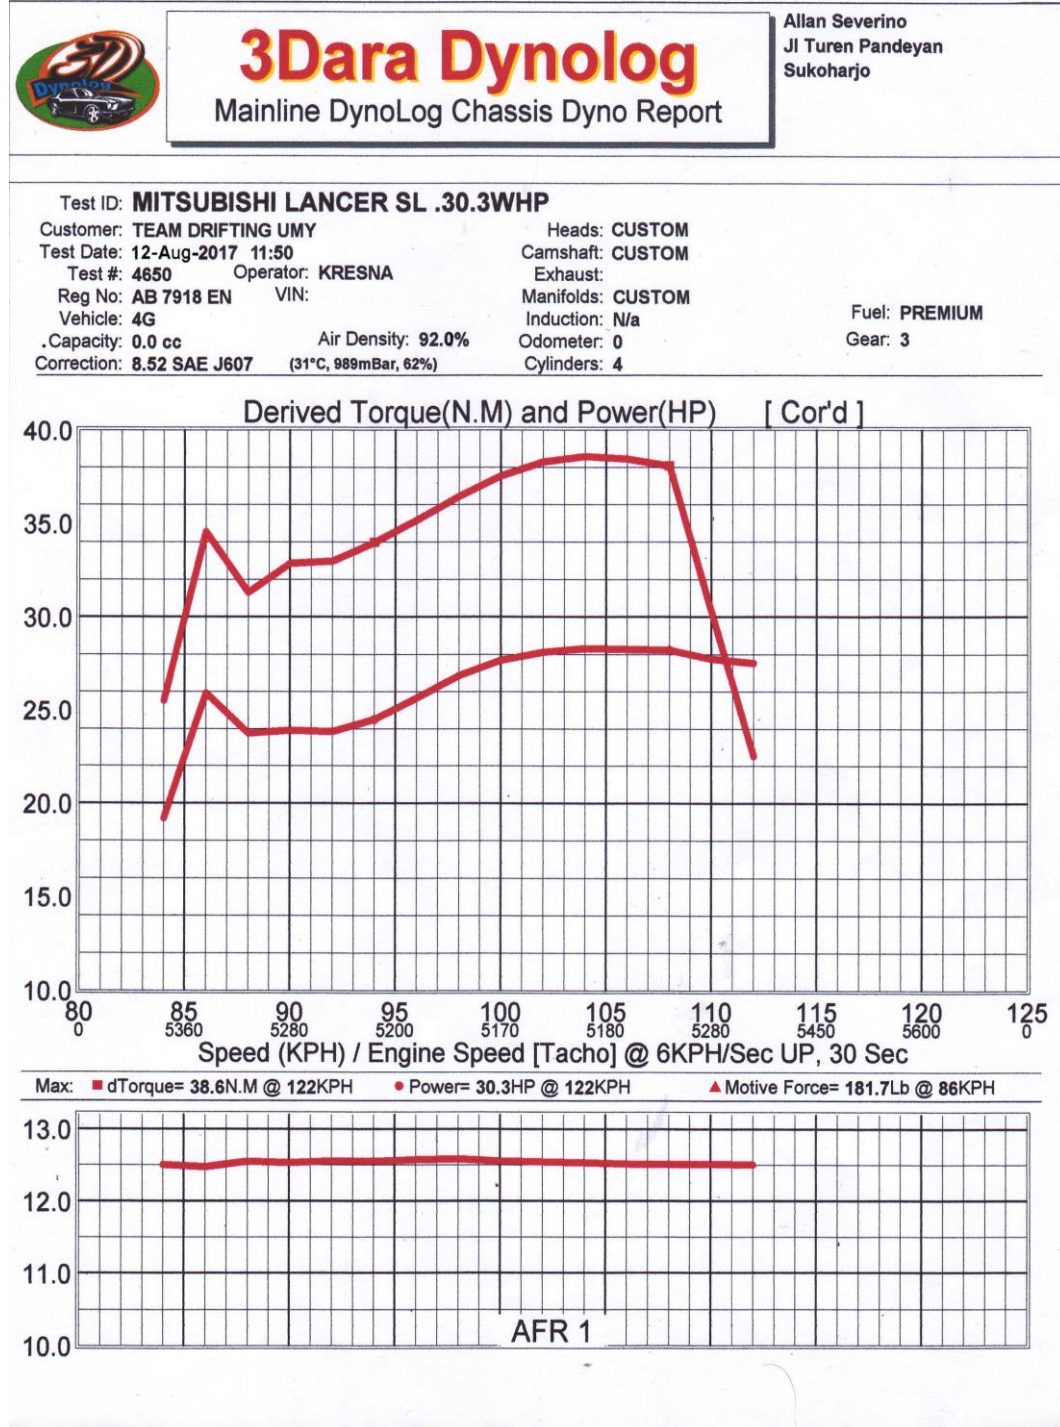
Lampiran 2

Data Dynotest setelah dilakukan development

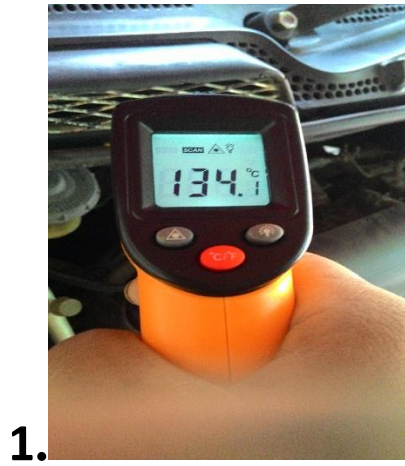
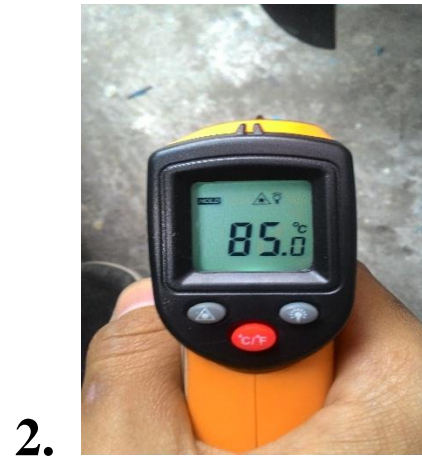
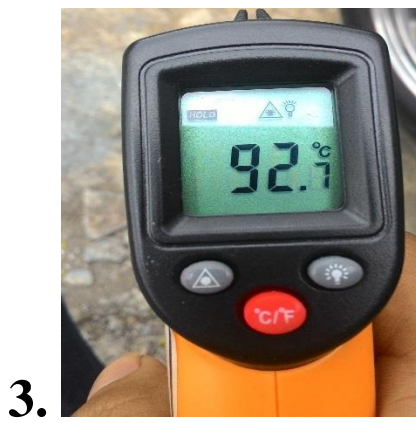
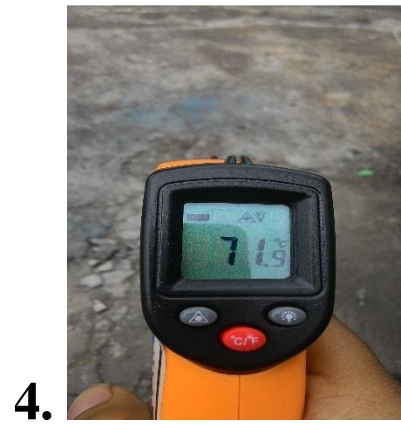
Lampiran 3

Data Awal Suhu Panas Kendaraan

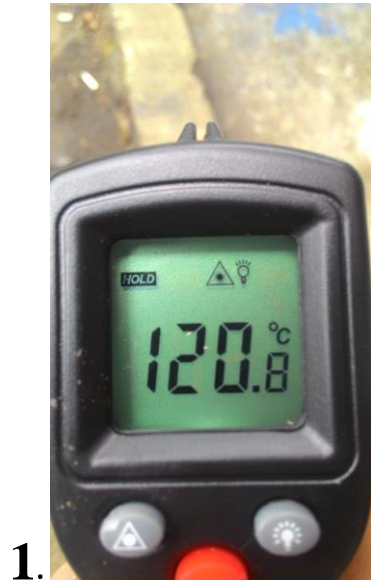
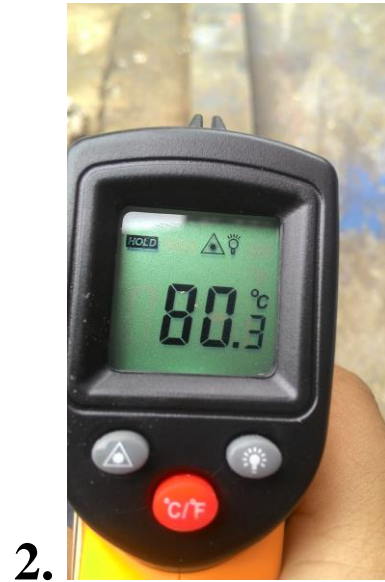
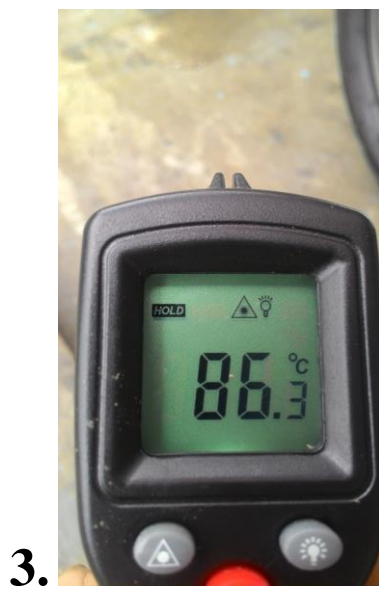
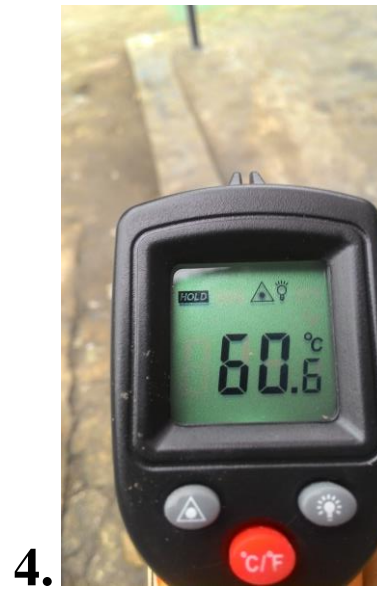
Lampiran 4

4.1.1 Data Panas Suhu mesin setelah di development

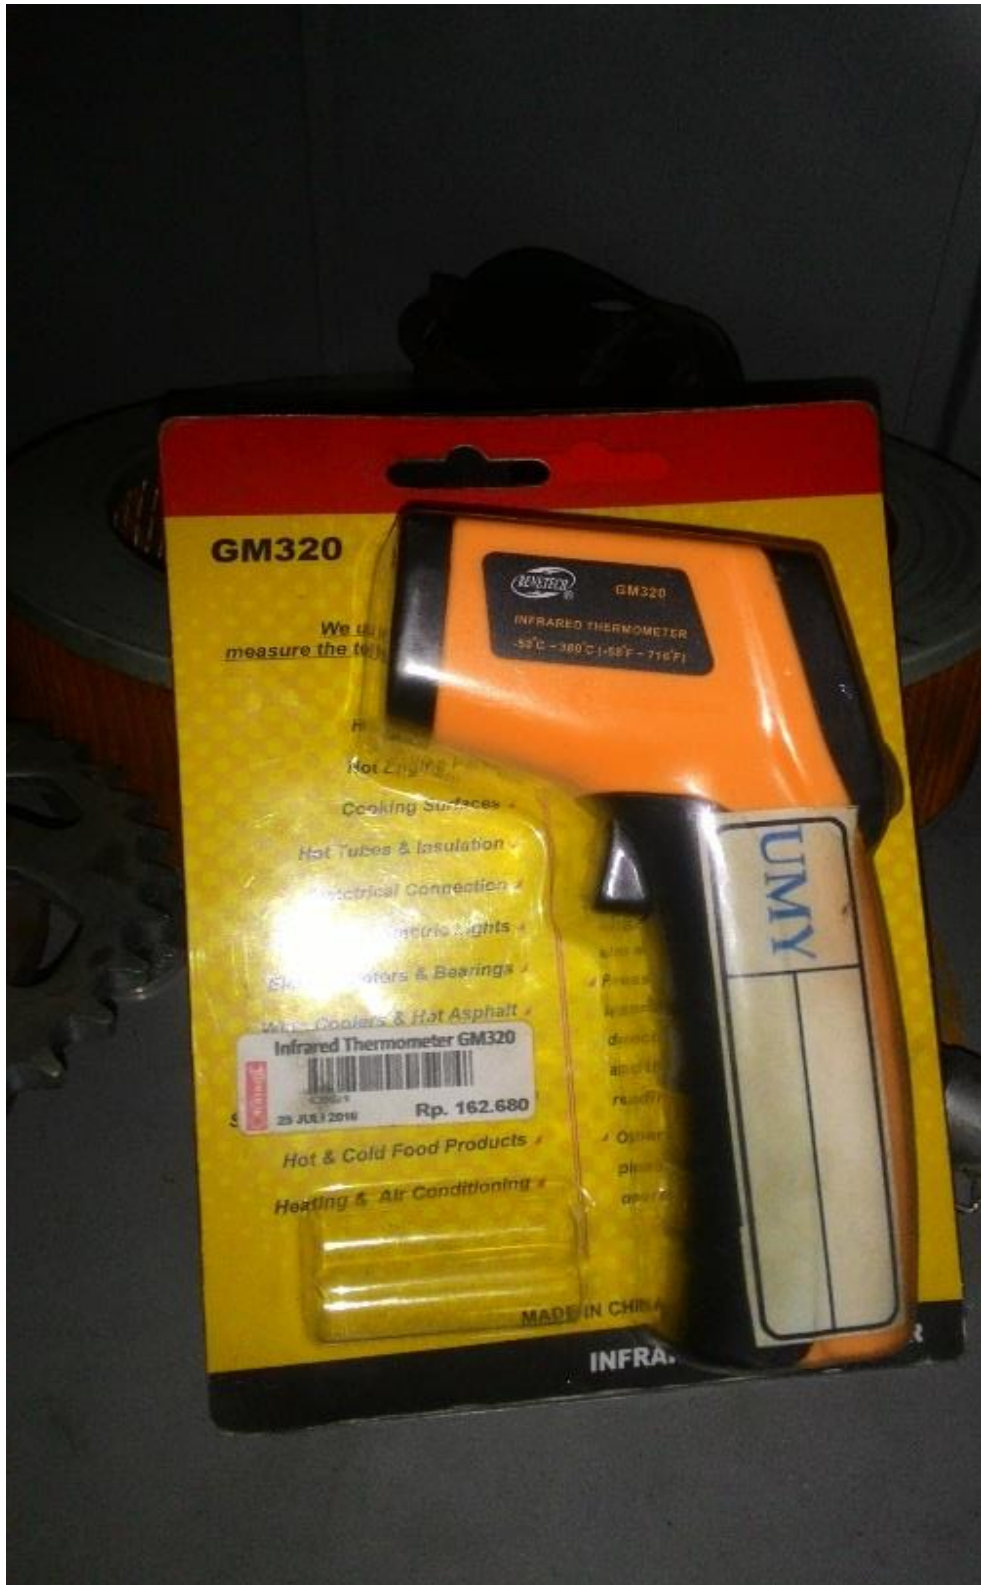
Lampiran 5

Alat ukur pengukur suhu infrared thermometer

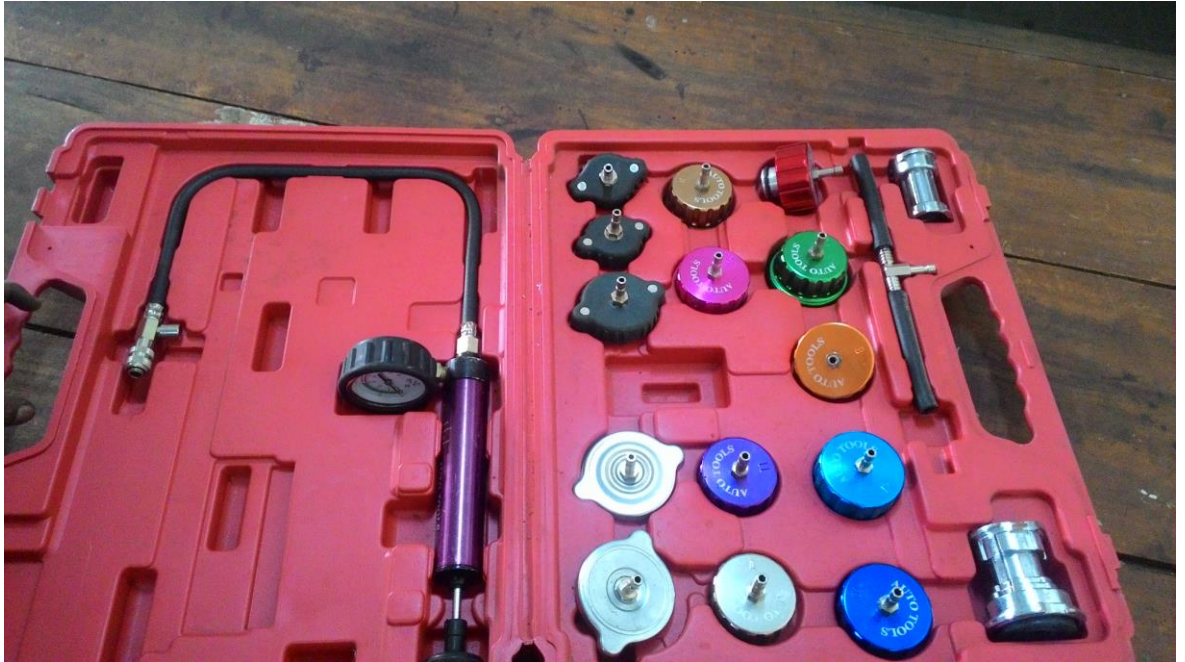
Lampiran 6

Alat Radiator Cup Tester

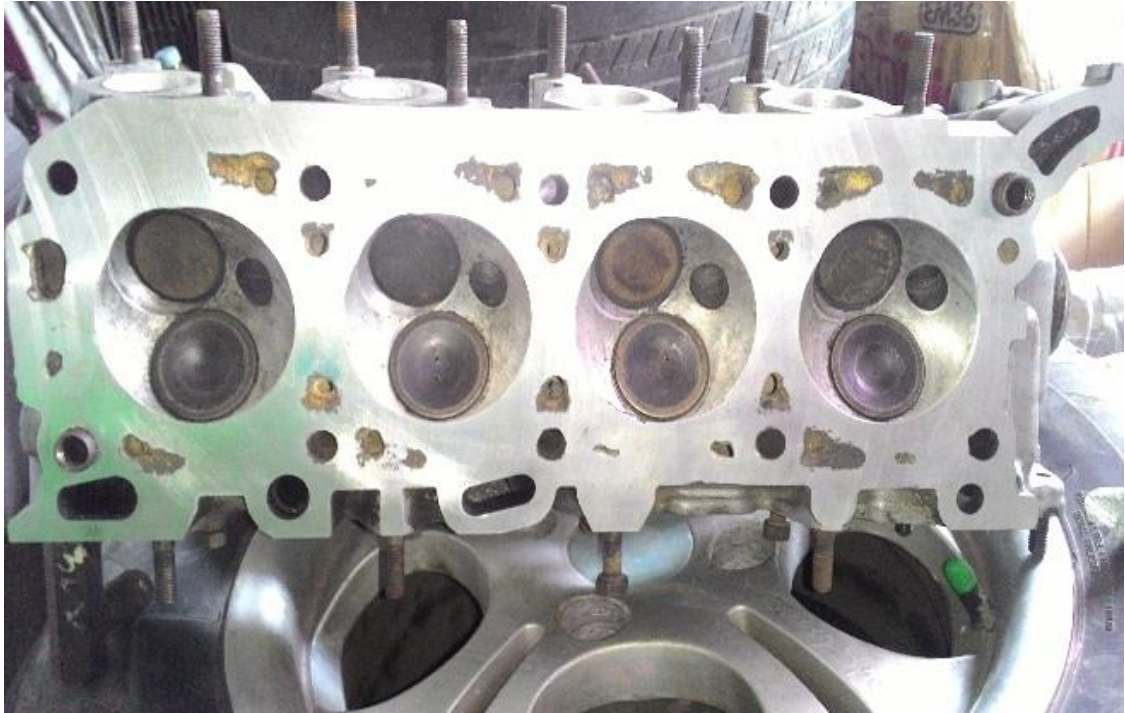
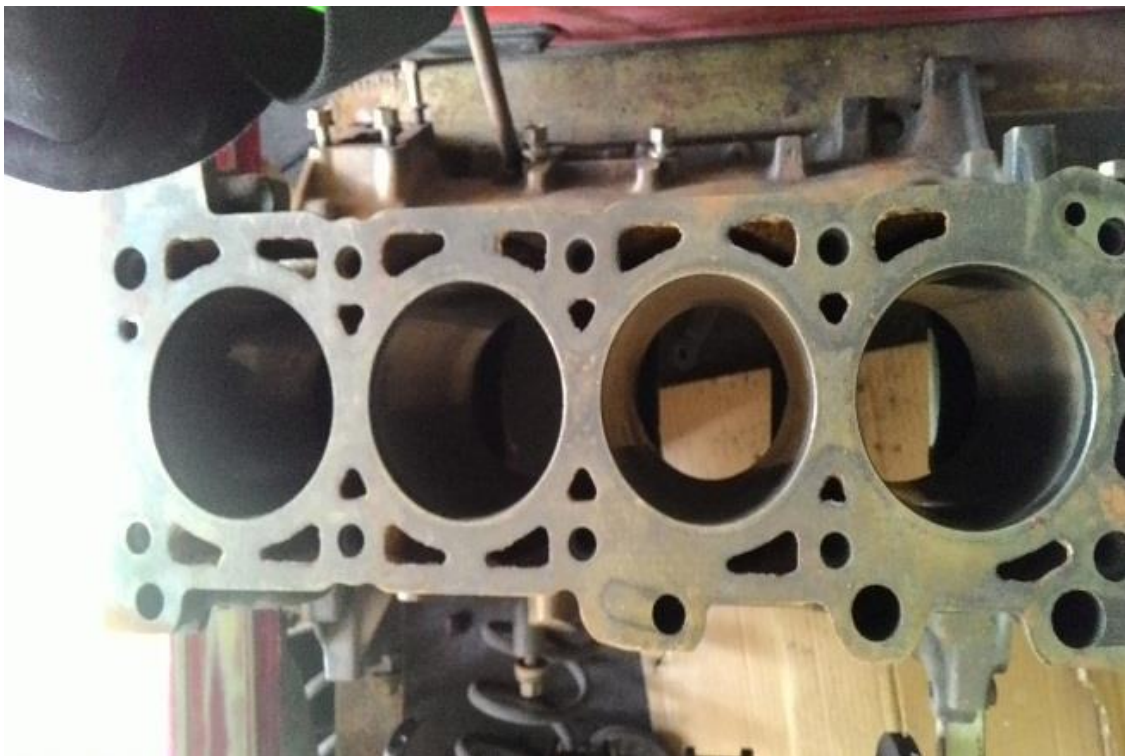
Lampiran 7

Kondisi *Waterjacket* Mitsubishi Lancer SL
