LAMPIRAN

Hasil Pengujian Ketebalan

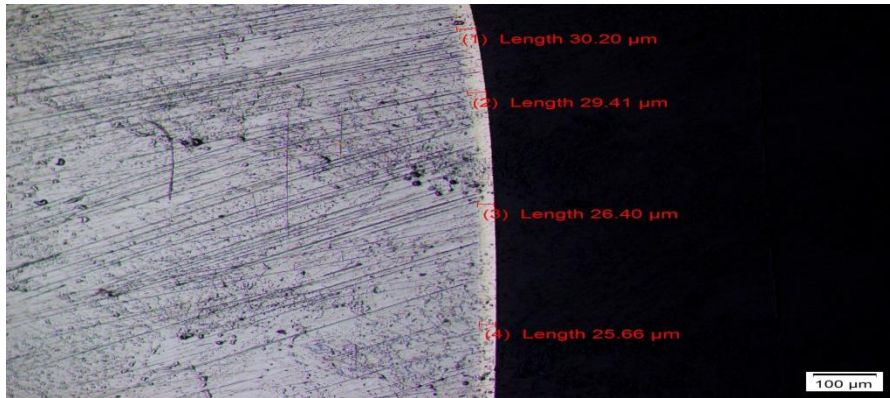
Segmen 1

a. Posisi Pencelupan Spesimen Menghadap Langsung ke anoda

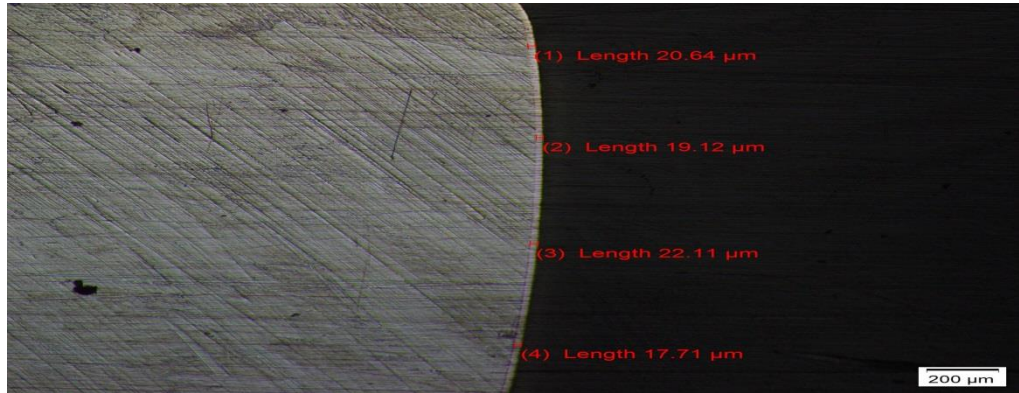
Segmen 1

b. Posisi Pencelupan Spesimen Menyampingi Anoda

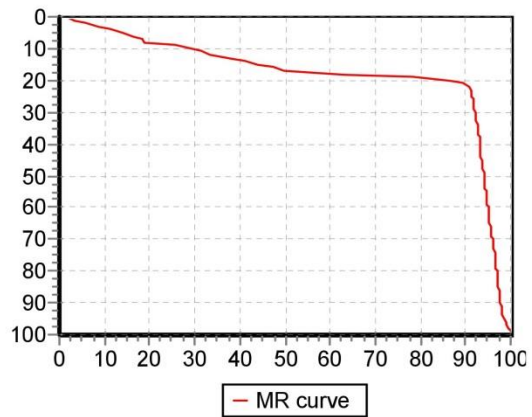
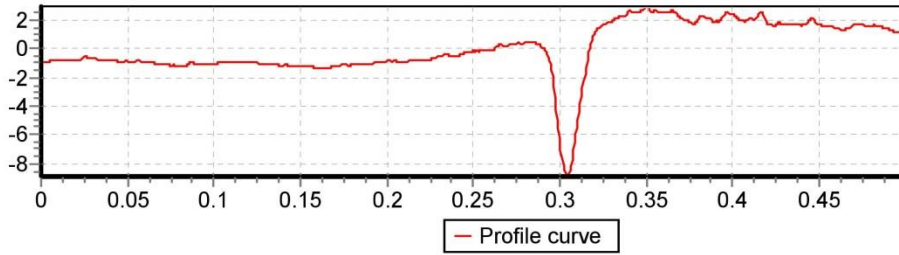
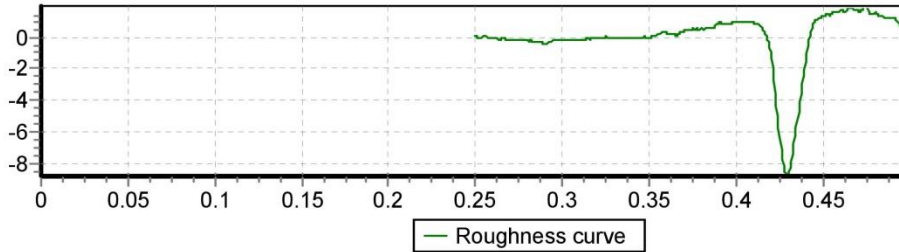
Report of Surface Roughness Tester

Ra = 0.971 μm
R3z = 0.151 μm
Rv = 8.772 μm
Rp = 1.966 μm
Rt = 10.738 μm
Rz = 10.738 μm
RS = 0.037 mm
Rsk = -3.093
RSm = 0.250 mm
Rq = 1.874 μm
RzJIS = 2.470 μm
R3y = 0.151 μm
Rku = 13.141

Cutoff: 0.25mm

Range: μm 40

Filter: GAUSS

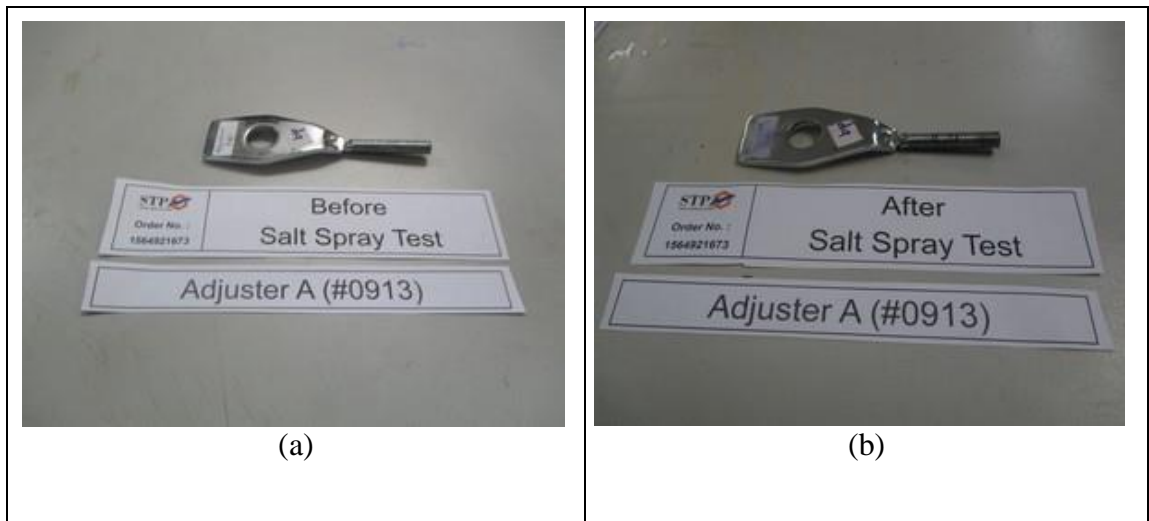
| No. | Nama Sampel | Observasi Visual |
|---|---|--|
| 1. | Adjuster A | Terjadi karat $\pm 2\%$ dipermukaan sampel |

Gambar 4.11 Sampel Adjuster A, (a) sebelum dan (b) sesudah pengujian Salt Spray

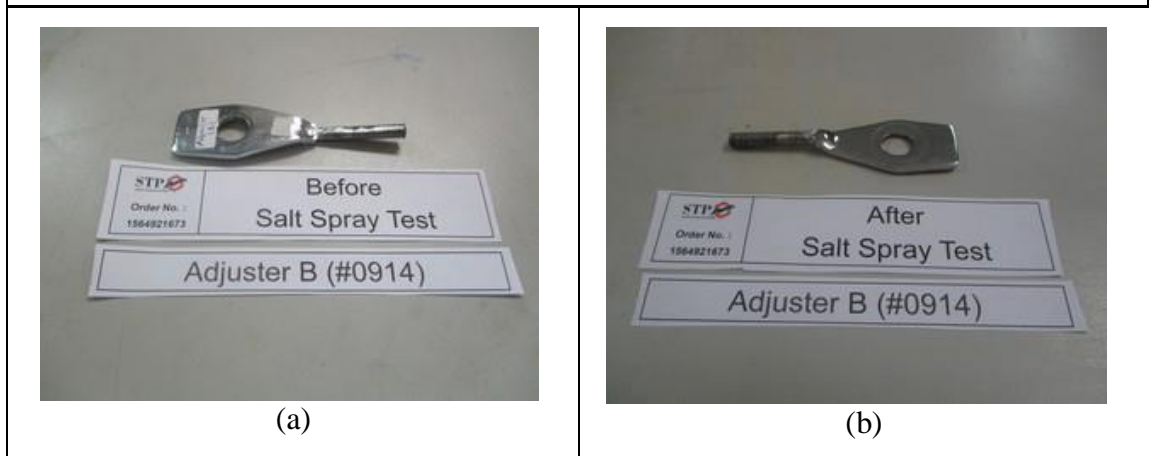
| No. | Nama Sampel | Observasi Visual |
|---|---|--|
| 2. | Adjuster B | Terjadi karat $\pm 2\%$ dipermukaan sampel |

Gambar 4.12 Sampel Adjuster B, (a) sebelum dan (b) sesudah pengujian Salt Spray
