SUMMARY

Mount Merapi, located on the border of the Special Region of Yogyakarta and Central Java, is one of the most active volcanoes in Indonesia. Since 1548 the volcano has erupted 68 times. The Merapi eruption in 2010 with a scale of VEI 4, produced materials of different sizes, from small (finer) to large size (boulder). The volume of material produced is estimated at 140 million m³, equivalent to an eruption that occurred in 1822. The material has had an impact on several factors, one of the factors is morphological changes in rivers in the Merapi area. The morphological changes can be caused by the results of erosion and sedimentation processes due to pyroclastic flows and debris flows. In addition, the changes in river morphology can be caused by human activities, such as mining sand in a river channel. Monitoring changes in river morphology can be investigated with Digital Elevation Model (DEM) and remote sensing data. This study aims to determine morphological changes in rivers in the Mt. Merapi after the 2010 eruption and to determine a suitable sand mining capacity in the rivers on the Mt. Merapi area, especially in the Progo River. The research on river morphology chan

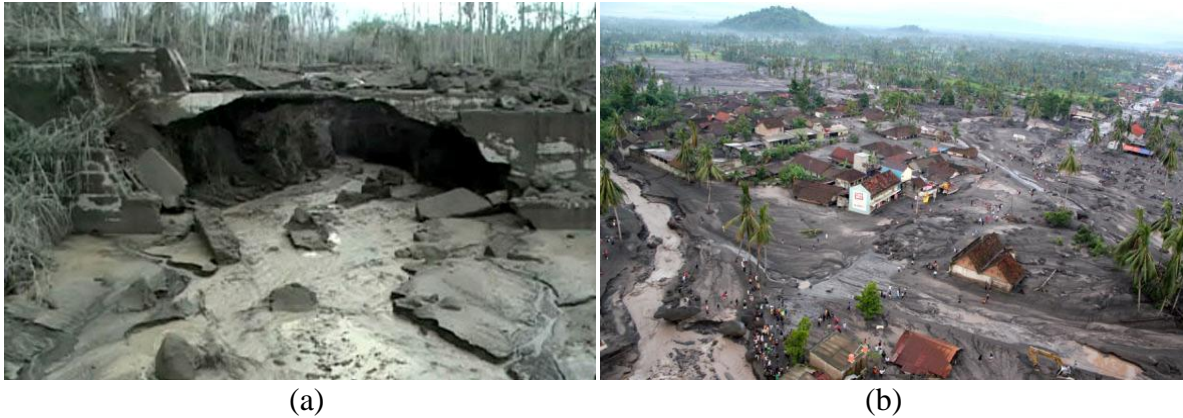
Figure 1. (a) A Damage *Check dam* in Putih River, (b) Deposited Sediment in Salam Sub District, Magelang Regency

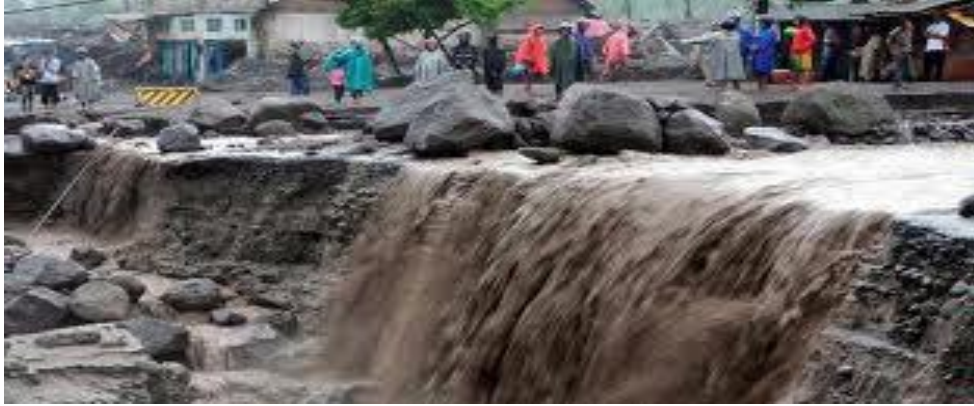
Figure 2. A Debris Flow in Putih River, Magelang Regency

Lavigne, et al. (2003) conducted a study to describe why debris flows are one of the main risks caused by Mount Merapi. Aisyah and Purnamawati, (2012) conducted a study to find out the impact caused by the debris flows due to the eruption of Mount Merapi in 2010. Puspitosari and Sumaryono, (2011) conducted a study to find out the damage that occurred in Sabo buildings due to debris flows in Merapi area the post Merapi eruption in 2010, where 77 sabo buildings were damaged. Munawaroh and Widiyanto, (2013) conducted a study to determine the level of danger of lahar and the distribution of damage that occurred in sediment control structures, infrastructure, settlements and agricultural land of Putih River after the eruption of Mount Merapi in 2010. Widagdo and Hadmoko, (2015) conducted research for investigation the morphological changes of Kali Putih after the 2010 Merapi eruption and the effects on the surrounding environment.

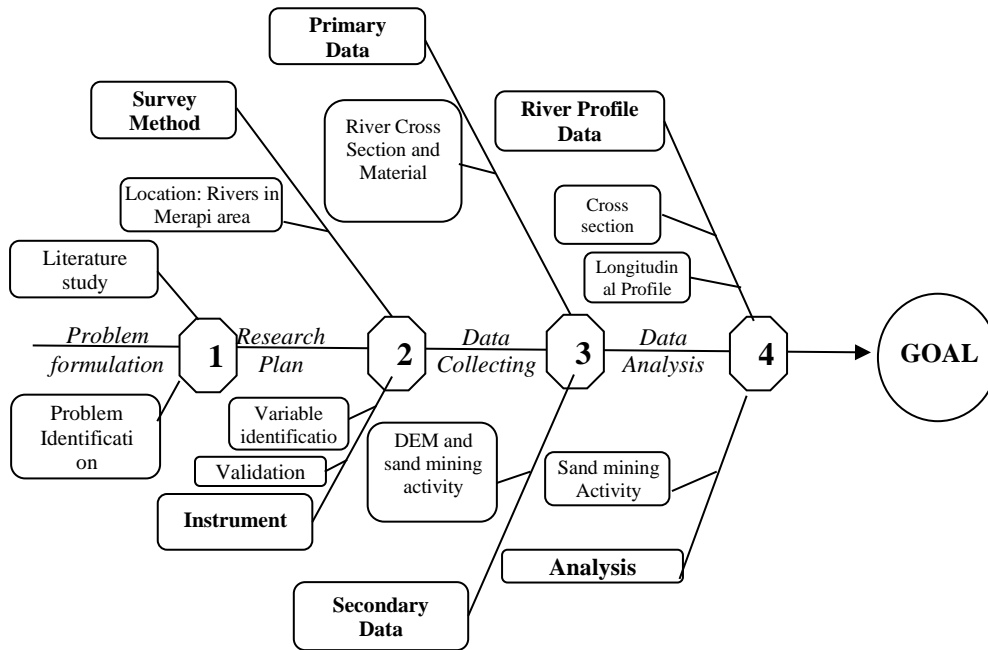
Gambar 7. Research steps

This research is conducted to determine the morphological changes of rivers in the Mount Merapi area caused by lava floods or sand mining activities. In addition, this study was also conducted to determine the mining activities of sand and the potential capacity / volume of mining that is still permitted. To find out the change in river morphology, it is based on Digital Evaluation Model (DEM) and remote estimation (JP) data. DEM data used are the results of LIDAR (Light Detection and Ranging) measurements in 2012, DEM from Digital Globe Satellite (2015) and DEM from Google Earth Pro. From the DEM data, a morphological change projection is made for the cross section changes and cross river profile. From the results of these projections it can be seen that riverbed aggradation-degradation and river bank erosion-sedimentation. The projection process for the transverse and longitudinal profile of the river is also assisted with the results of imagery from Google Earth Pro for 2012, 2015 and 2020. Results from projections based on digital data, will be confirmed by field surveys for several sample points reviewed. This survey will also take samples of materials that are in the sample points that are reviewed for grading tests in the laboratory. Monitoring of sand mining activities is carried out with secondary data from several sources. To determine the permissible sand mining potential, carried out by hydraulic measurements or based

on the results of projections from DEM and Google Earth Pro. The flowchart of the study is shown in Figure 7.
