## Rapid Visual Screening (RVS) for School Buildings after Earthquake in Lombok, West Nusa Tenggara, Indonesia

A Pujianto<sup>1</sup>, H Prayuda<sup>1</sup>, S A P Rosyidi<sup>1</sup>, F Monika<sup>1</sup> and R Faizah<sup>1</sup>

<sup>1</sup>Department of Civil Engineering, Faculty of Engineering, Universitas Muhammadiyah Yogyakarta, Bantul, Daerah Istimewa Yogyakarta, Indonesia

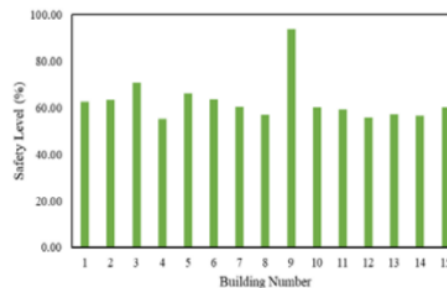
Figure 3. Building safety level in vertical components

Figure 3 shows that 5 school buildings were moderately damaged, while 9 buildings had moderate damage to vertical components. The damage that occurs is not too damaging to the performance of structural components so that only non-structural components need to be improved. Improvements can use the retrofitting method.

As the material for future suggestions, it should be noted how good methods are in the process of building wall components. The damage caused by this earthquake is caused by a poor connection, so it is necessary to think about how good the connection between each building component.

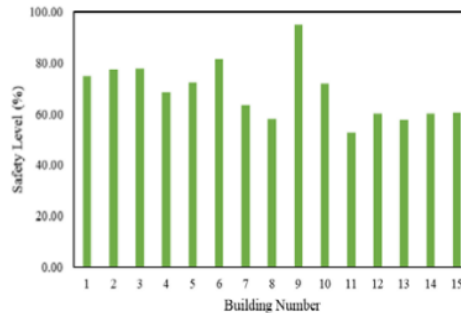
Figure 4. Building safety level in horizontal components

Figure 4 shows the results of the building security level from the side of the horizontal component. This component assesses the feasibility of the beam, plate and roof structure. The results obtained showed that as many as two buildings did not experience significant damage, while 7 buildings suffered minor damage to the plates and roof. A total of 6 buildings were moderately damaged. Most

damage is found on the roof components. Based on the results of direct observation in the field, the roof structure in general still uses wood construction that is quite old.

Apart from age, this damage is also affected by improper construction methods for roof structure work; it can be seen that there is no good connection between tile and easel made of steel structure so that in the event of a shock, tile is very easy to lose and fall. General damage that occurs in the horizontal component in the form of a ceiling drop due to not having a strong bond. While structural conditions only experience mild to moderate cracks, which are not expected to disturb structural conditions if quickly repaired.

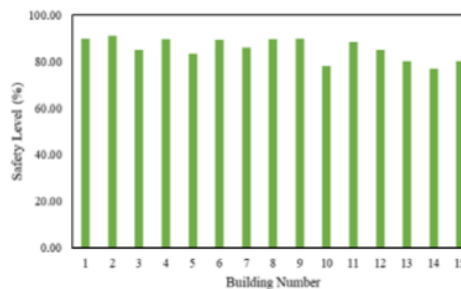
Figure 5. Level of building security on foundation components

The foundation component shown in Figure 5 shows that most of the buildings did not experience significant damage. 11 buildings were not damaged on the foundation, and 4 buildings were damaged on the foundation. This damage occurs on the sloop, which appears to have a small crack. In some buildings that are quite old, the lack of maintenance on the foundation components causes some components to be long enough damage.

In examining these foundation components, there are quite a number of obstacles. Direct inspection methods that rely on visual vision are certainly not 100% can conclude the foundation is in good condition or not good. It is necessary to examine the foundation with better technology so that it can be known with certainty the foundation condition whether it is still functioning properly or not. Visual inspection can only detect damage if in the building area, especially in it there is a decrease in soil or sloop conditions that are clearly visible from outside the building.

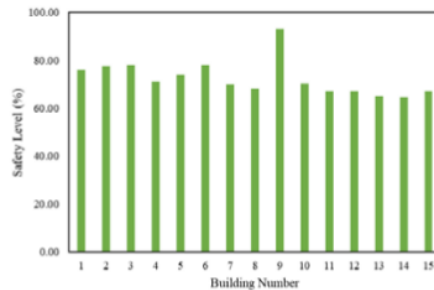
Figure 6. The overall building safety level

Figure 6 describes the level of security of the building as a whole. Based on the results of the analysis, it was found that only 1 building was not damaged, while 6 school buildings suffered minor damage and 8 school buildings suffered moderate damage. There were no buildings that were severely

damaged. In Figure 6, it explains the percentage of damage to buildings, and this shows that 53% of school buildings were moderately damaged and 40% of buildings suffered minor damage.

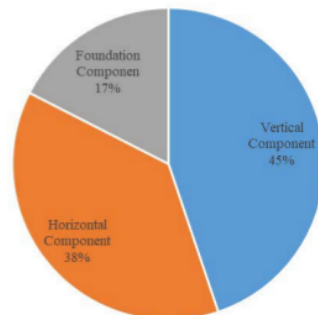
**Figure 8.** Percentage of causes of damage to buildings after the earthquake

Figure 8 shows, the results of the percentage of damage that occurs in each component examined. 45% of the damage that occurs in all buildings comes from vertical components, while from horizontal components is 38% and from the foundation, components are 17%. This shows that vertical and horizontal components are very vulnerable to damage when an earthquake occurs.

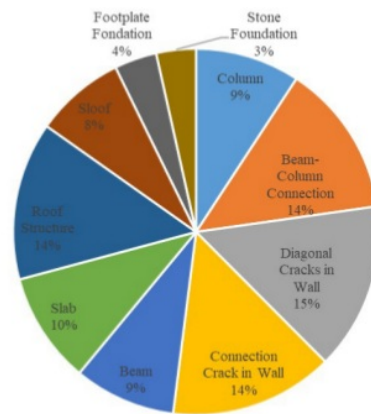
**Figure 9.** Percentage of damage to each component of a building

Figure 9 is the percentage level of damage that occurs in each component that is carried out the assessment. Overall on the three main components, divided into 10 components. The results of the analysis show that the wall components that have diagonal cracks, wall connections with beams or columns and beam-column joints are the biggest part, which is damaged at 14% and 15% followed by damage to the roof structure with a damage rate of 14%.

It can be concluded that these four components are the components that are most prone to damage and can endanger the building user. Meanwhile, other components also contribute to damage in the event of an earthquake, structural components such as beams, plates, and columns contribute to damage of 9% to 10% and Sloop accounts for damage of 8%. This component of the structure also needs to be taken care of in the construction process.

The slab component can only be detected if the building is more than 1 floor, while on the ground floor of the building only damage occurs when the ceramic used is broken, and there are a few small cracks on the plate. Overall, hollow beam component cracks occur in the Drag section of the beam, and it can be concluded that shear and flexural damage often occurs together this is evident from the crack position that always occurs in the sliding location and bending location. Meanwhile, some column components experience sliding damage.
