Pushover Analysis of Partially Strengthened Column Structures on an Existing Multi-story Building

Abstract. A pushover analysis was conducted to evaluate structural performance of an extended building structure subjected to simulated seismic loads. The Inna Garuda Hotel was selected as a building object of this research focusing on the extension building only. This 7-story reinforced concrete building has been functioned as a hotel building in the Yogyakarta City of Indonesia for over 30 years. Preliminary results of this analysis indicated that the performance level of this building was categorized as an immediate occupancy (IO), however, the plastic hinges on the slim column structure components occurred. Given this condition, the structure of the building does not fulfill the concept of a strong column-weak beam (SCWB). The research objective is to follow up on the potential of building collapse due to the column structure weakness by conducting a research on the strengthening of slim column elements. A pushover analysis was carried out using ETABS software. A strengthening technique was adopted by enlarging the dimensions of the slim column gradually. In this study, the slim c

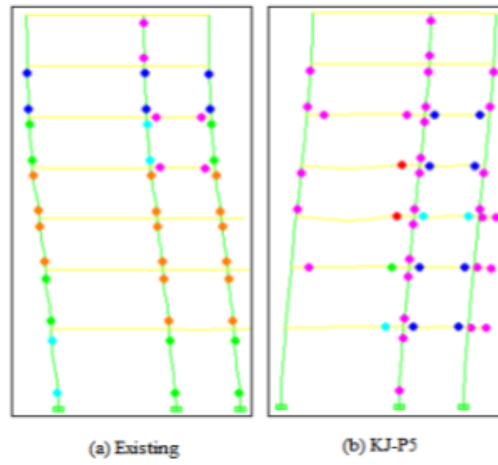
Fig. 11 Plastic hinge location of slim columns: final step of the A-frame in X-direction (N-S)

Fig. 11 to Fig. 18 show that by strengthening the cross-section of indicated weak-column elements (slender columns) changing the level of damage and improve the performance level of the extended building of Inna Garuda Hotel. The result of pushover analysis of the building structure proves that the reinforced column elements that have been strengthened contribute significantly to the improvement of overall structural performance.

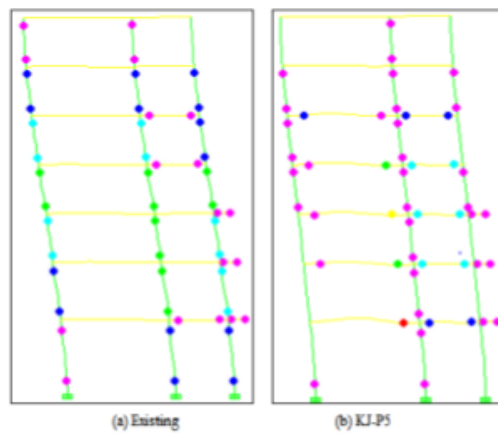
Fig. 15 Plastic hinge location of slim columns: final step of the A-frame in X-direction (W-E)
